2013 Operations, Maintenance, and Monitoring Report

East Mud Lake Marsh Management (CS-20)

State Project Number CS-20
Priority Project List 2

September 2013
Cameron Parish

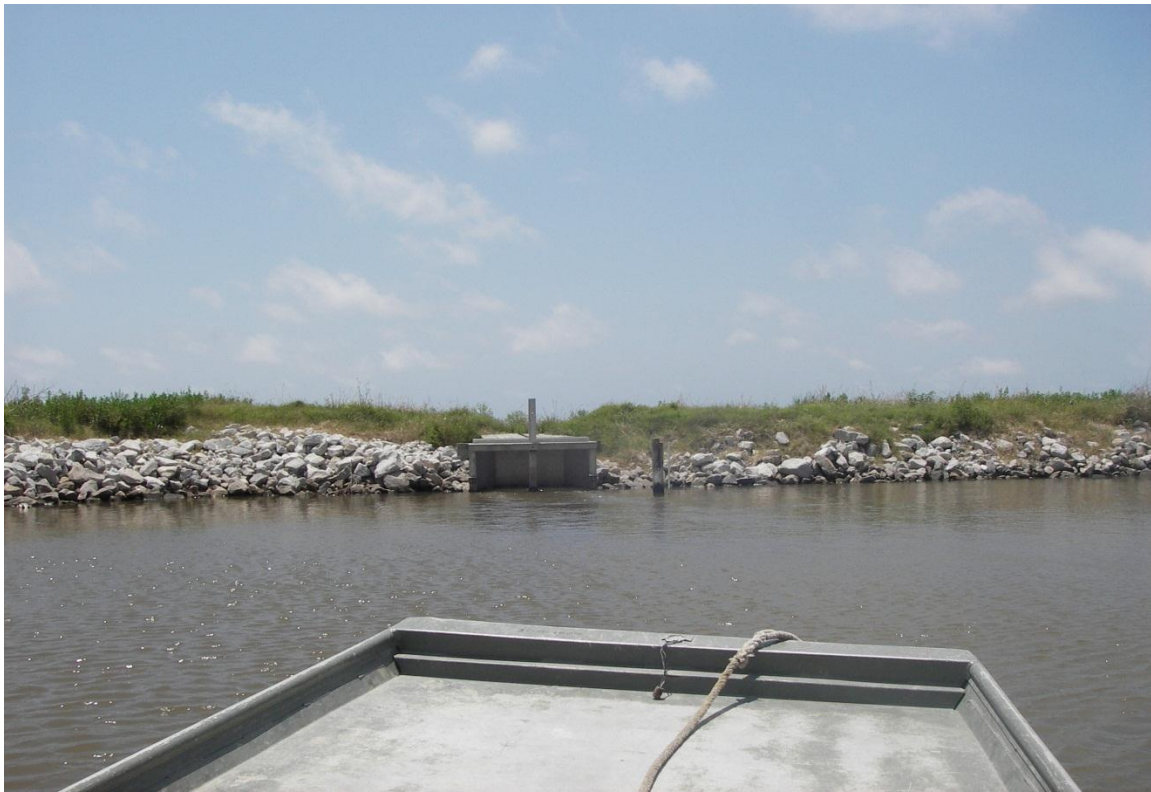
Photo 15, Structure 3

This is also a pre-existing structure that was incorporated into the CS-20 Project. Walkways are in excellent shape. Rock placed around the structure has stabilized the banks. (Photos: Appendix A, Photos 15 & 16).
